**Project Description:** WinCan Import in Miraculix Standard

**Knight and Day Drainage & Plumbing Limited***Unit 42, Greenway Business Centre Harlow Business Park**Tel. 01279 456008**admin@knightanddayltd.co.uk***Project Information****Project Name****Project Number****Project Date****Client**

**Section Inspection - 03/02/2026 - MHCW02X**

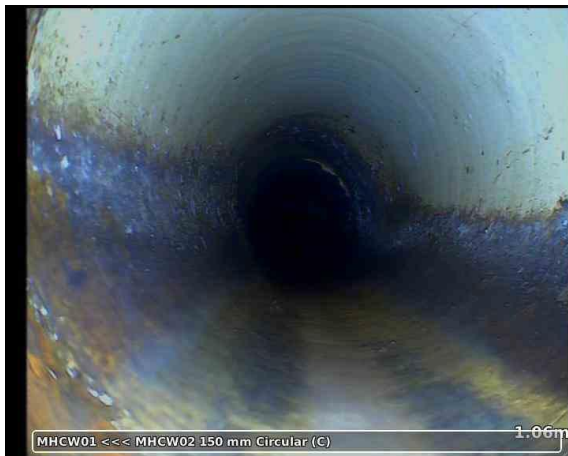
20260203-130158-snap0002.jpg, 00:01:31, 1.06 m  
Cured-in-place lining ends at this point

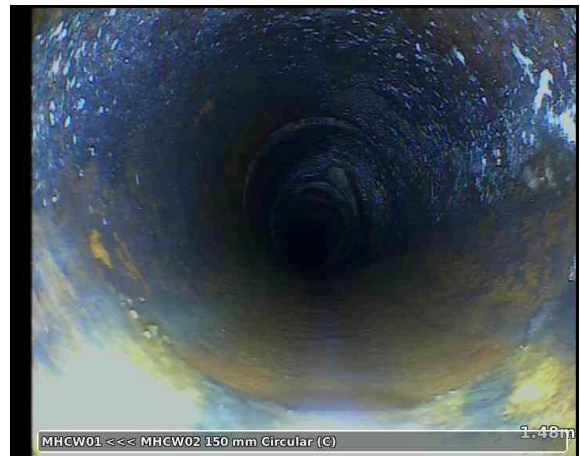
20260203-130158-snap0003.jpg, 00:01:53, 1.48 m  
Cured-in-place lining ends at this point

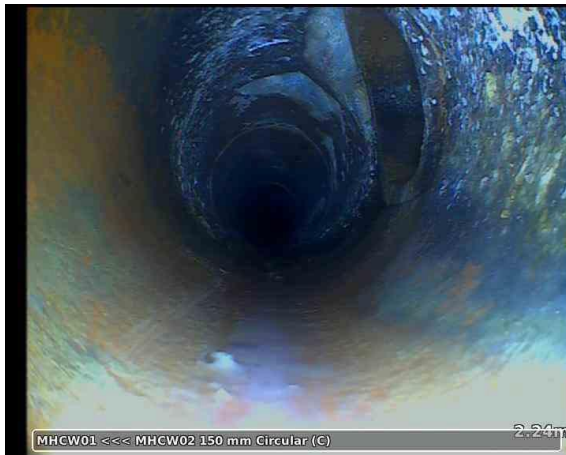
20260203-130158-snap0004.jpg, 00:02:17, 2.20 m  
Connection other than junction at 3 o'clock, 100mm dia

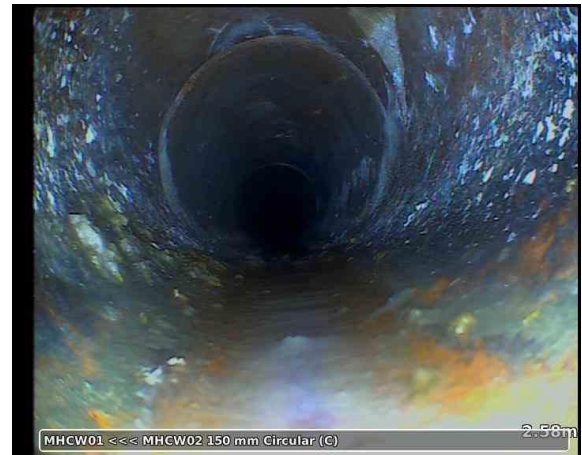
| Item No. | PLR | Grade | Description |
|---|---|---|---|
| 1 | MHCW02X | 3 | Cracks, spiral at joint from 11 o'clock to 12 o'clock |

| Scale: | 1:101 | Position [m] | Code | Observation | MPEG | Photo | Grade |
|---|---|---|---|---|---|---|---|
| | 2.58 | CSJ | Cracks, spiral at joint from 11 o'clock to 12 o'clock | | 00:02:52 | 20260203-130158-sn ap0005.jp | 3 / 2 |

20260203-130158-snap0005.jpg, 00:02:52, 2.58 m  
Cracks, spiral at joint from 11 o'clock to 12 o'clock

Grade 3: Best practice suggests consideration should be given to repairs in the medium term.

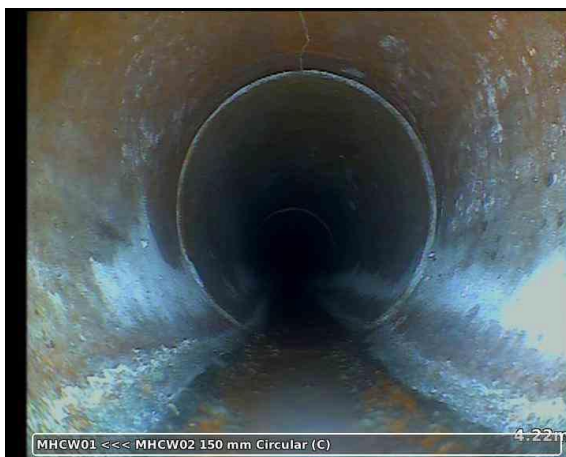
| Scale: | 1:101 | Position [m] | Code | Observation | MPEG | Photo | Grade |
|---|---|---|---|---|---|---|---|
| | 4.22 | CLJ | Crack, longitudinal at joint at 12 o'clock | | 00:03:20 | 20260203-130158-sn ap0006.jp | 2 / 2 |

20260203-130158-snap0006.jpg, 00:03:20, 4.22 m  
Crack, longitudinal at joint at 12 o'clock

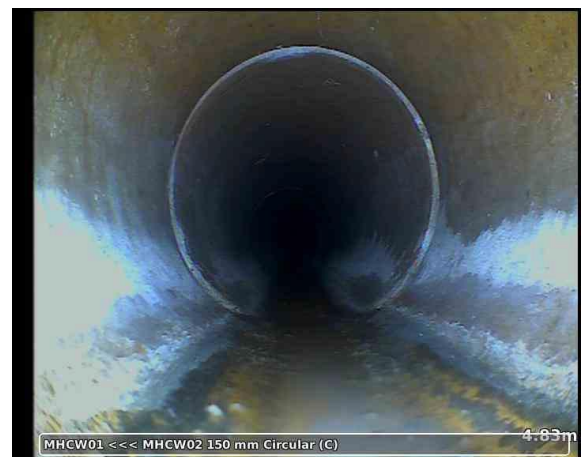
| Scale: | 1:101 | Position [m] | Code | Observation | MPEG | Photo | Grade |
|---|---|---|---|---|---|---|---|
| | 4.83 | CLJ | Crack, longitudinal at joint at 12 o'clock | | 00:03:47 | 20260203-130158-sn ap0007.jp | 2 / 2 |

20260203-130158-snap0007.jpg, 00:03:47, 4.83 m  
Crack, longitudinal at joint at 12 o'clock

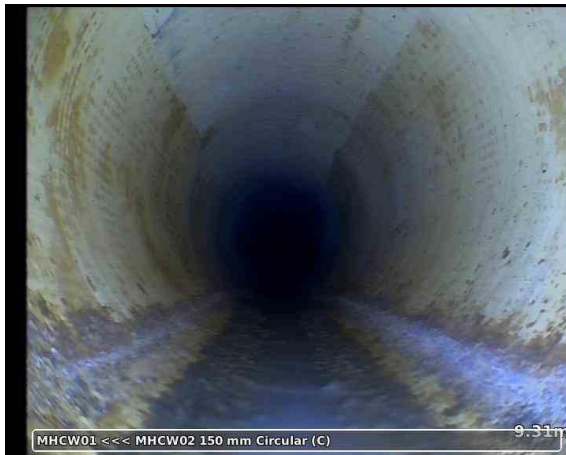
20260203-130158-snap0008.jpg, 00:04:51, 9.31 m  
Cured-in-place lining ends at this point

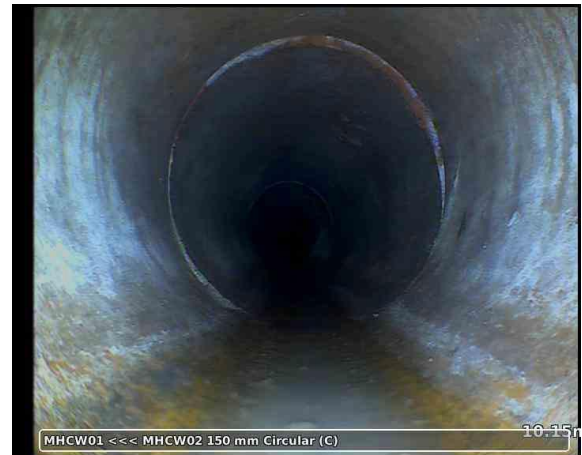
20260203-130158-snap0009.jpg, 00:05:19, 10.15 m  
Cured-in-place lining ends at this point

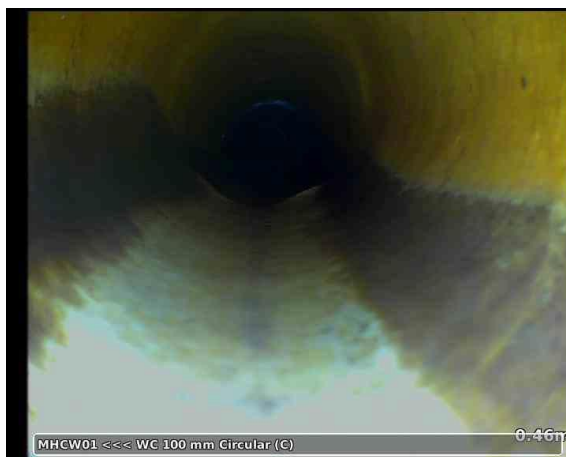
20260203-131157-snap0002.jpg, 00:00:16, 0.46 m  
Line deviates up

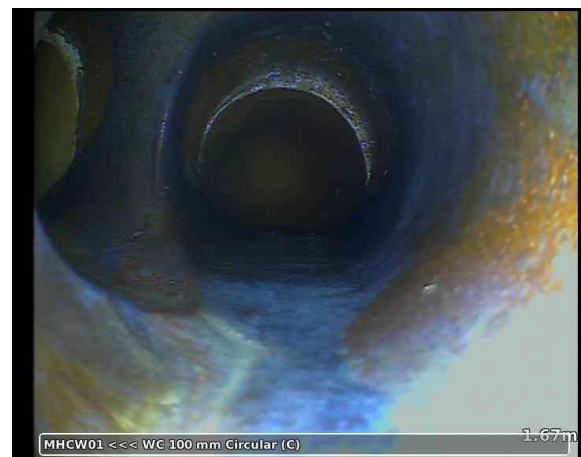
20260203-131157-snap0003.jpg, 00:00:45, 1.67 m  
Junction at 10 o'clock, 100mm dia

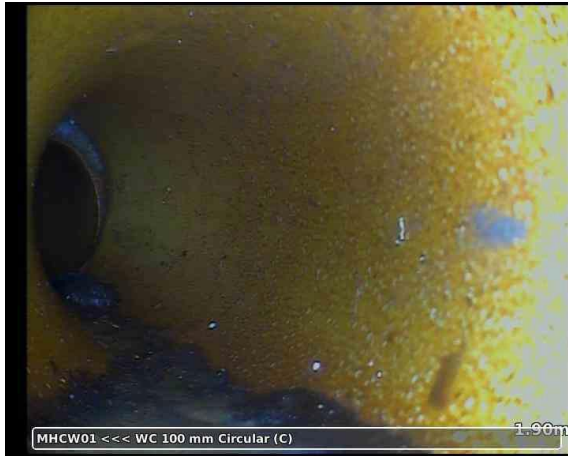
20260203-131157-snap0004.jpg, 00:01:03, 1.82 m  
Line deviates left

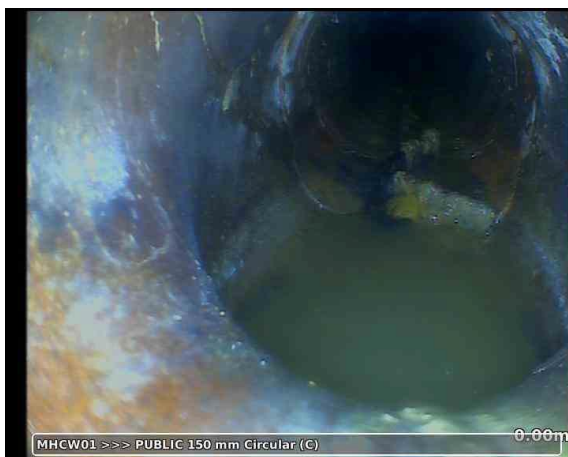
20260203-131500-snap0002.jpg, 00:00:22, 0.00 m  
Line deviates down, INTERCEPTOR

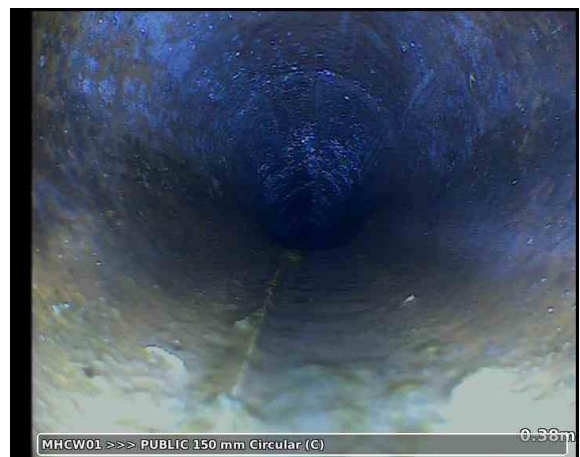
20260203-131500-snap0003.jpg, 00:01:00, 0.38 m  
Cured-in-place lining ends at this point

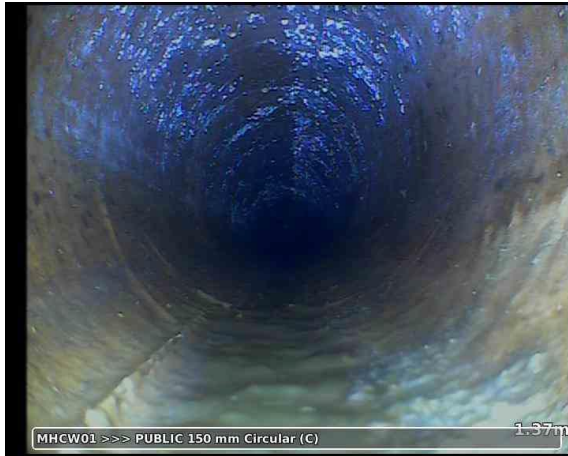
20260203-131500-snap0004.jpg, 00:01:16, 1.37 m  
Line deviates down

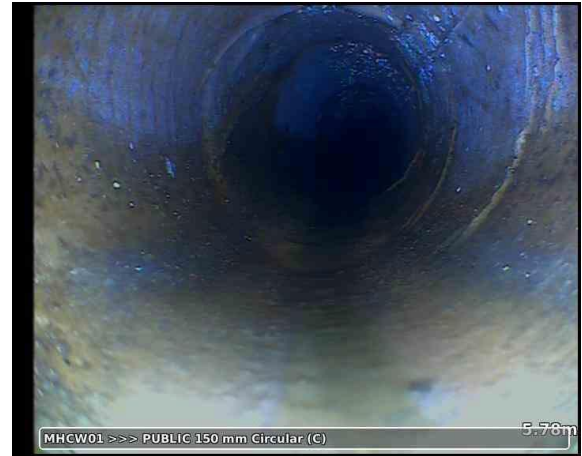
20260203-131500-snap0005.jpg, 00:01:41, 5.78 m  
Line deviates right

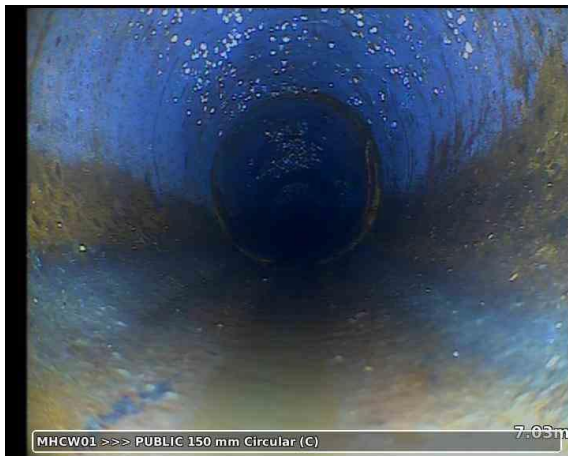
20260203-131500-snap0006.jpg, 00:02:03, 7.03 m  
Cured-in-place lining ends at this point

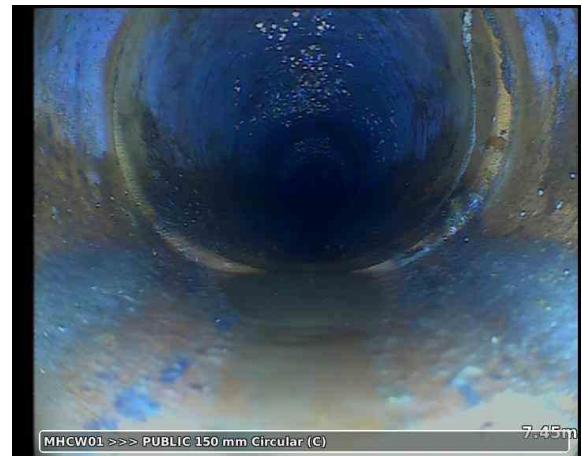
| Scale: 1:127 | Position [m] | Code | Observation | MPEG | Photo | Grade |
|---|---|---|---|---|---|---|
| | 7.45 | FCJ | Fracture, circumferential at joint from 2 o'clock to 5 o'clock | 00:02:20 | 20260203-131500-sn ap0007.jp | 3 / 2 |

20260203-131500-snap0007.jpg, 00:02:20, 7.45 m  
Fracture, circumferential at joint from 2 o'clock to 5 o'clock

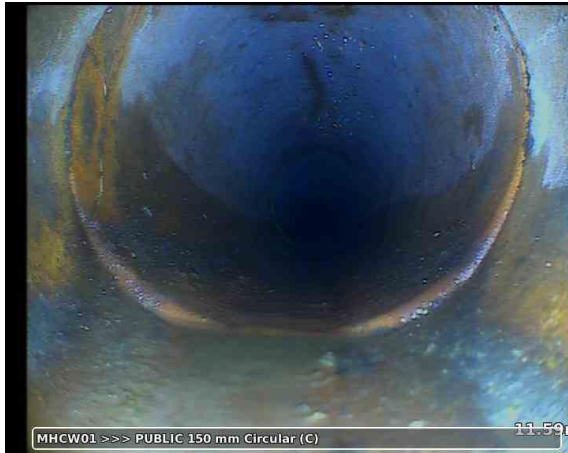
| Scale: 1:127 | Position [m] | Code | Observation | MPEG | Photo | Grade |
|---|---|---|---|---|---|---|
| | 11.59 | CCJ | Crack, circumferential at joint from 8 o'clock to 10 o'clock | 00:03:11 | 20260203-131500-sn ap0008.jp | 2 / 2 |

20260203-131500-snap0008.jpg, 00:03:11, 11.59 m  
Crack, circumferential at joint from 8 o'clock to 10 o'clock

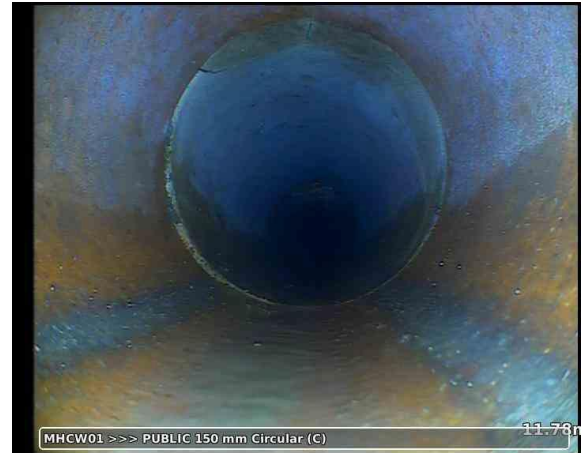
| Scale: 1:127 | Position [m] | Code | Observation | MPEG | Photo | Grade |
|---|---|---|---|---|---|---|
| | 11.78 | FCJ | Fracture, circumferential at joint from 10 o'clock to 12 o'clock | 00:03:35 | 20260203-131500-sn ap0009.jp | 3 / 2 |

20260203-131500-snap0009.jpg, 00:03:35, 11.78 m  
Fracture, circumferential at joint from 10 o'clock to 12 o'clock

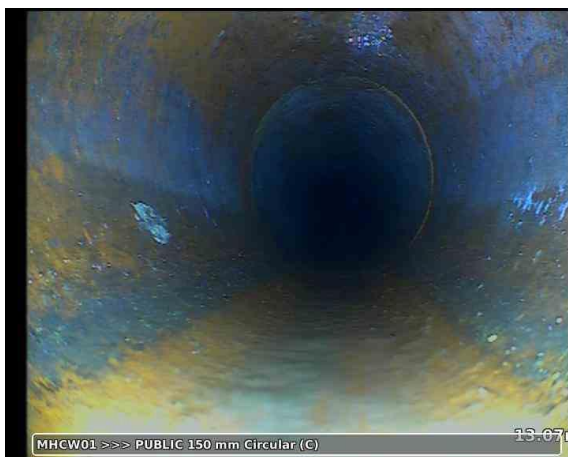
| Scale: 1:127 | Position [m] | Code | Observation | MPEG | Photo | Grade |
|---|---|---|---|---|---|---|
| | 13.07 | FCJ | Fracture, circumferential at joint from 12 o'clock to 1 o'clock | 00:04:12 | 20260203-131500-sn ap0010.jp | 3 / 2 |

20260203-131500-snap0010.jpg, 00:04:12, 13.07 m  
Fracture, circumferential at joint from 12 o'clock to 1 o'clock

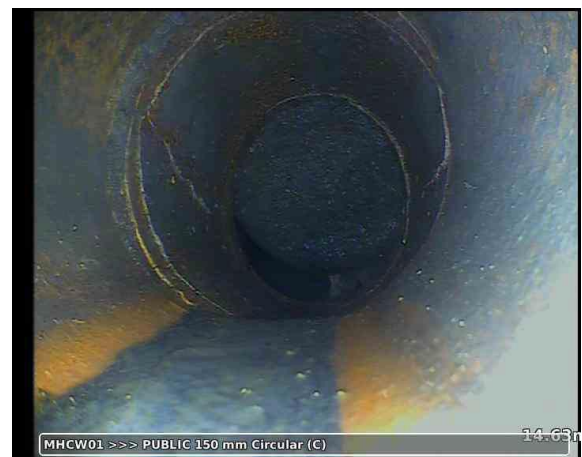
| Item No. | PLR | Grade | Description |
|---|---|---|---|
| 4 | MHCW01X | 4 | Fracture, spiral at joint from 12 o'clock to 12 o'clock |

| Scale: 1:127 | Position [m] | Code | Observation | MPEG | Photo | Grade |
|---|---|---|---|---|---|---|
| | 14.63 | FSJ | Fracture, spiral at joint from 12 o'clock to 12 o'clock | 00:05:07 | 20260203-131500-sn ap0011.jp | 4 / 2 |

20260203-131500-snap0011.jpg, 00:05:07, 14.63 m  
Fracture, spiral at joint from 12 o'clock to 12 o'clock

Grade 4: Best practice suggests consideration should be given to repairs to avoid a potential collapse.

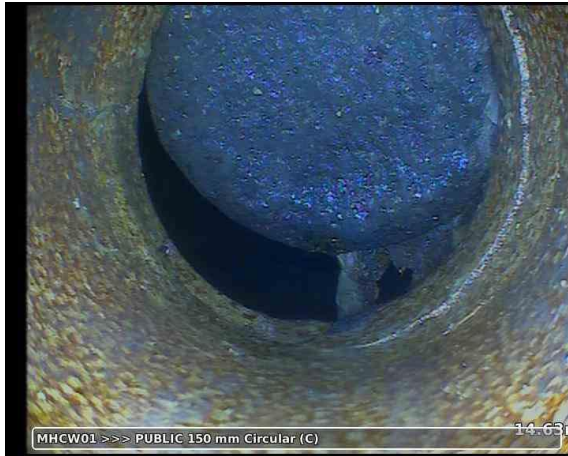
20260203-131500-snap0012.jpg, 00:05:29, 14.63 m  
General remark, SEWER FLAP

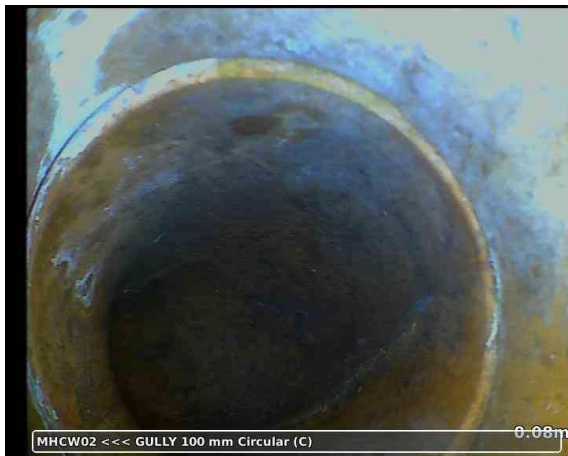
20260203-133026-snap0002.jpg, 00:00:29, 0.08 m  
Line deviates left

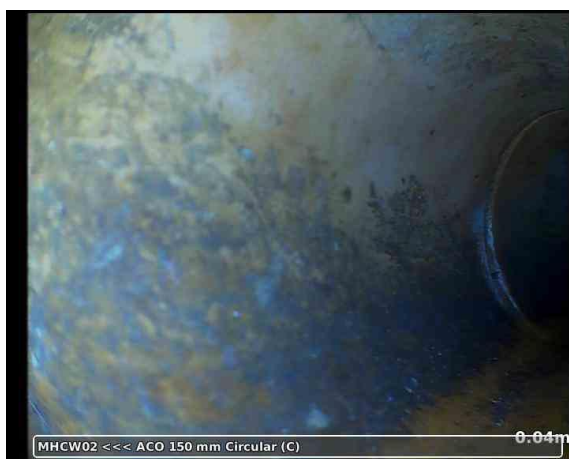
20260203-133243-snap0002.jpg, 00:00:31, 0.04 m  
Line deviates right

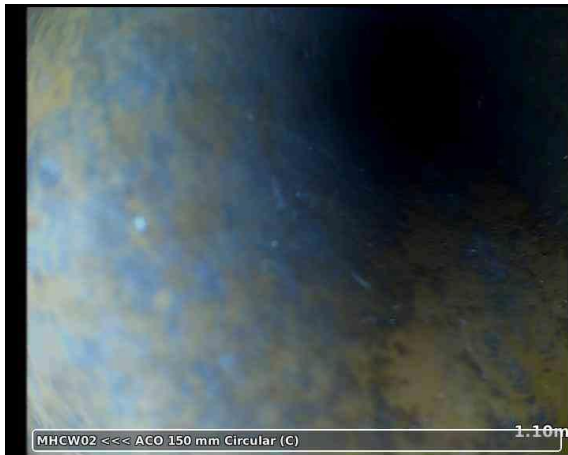
20260203-133243-snap0004.jpg, 00:00:52, 1.10 m  
Line deviates up

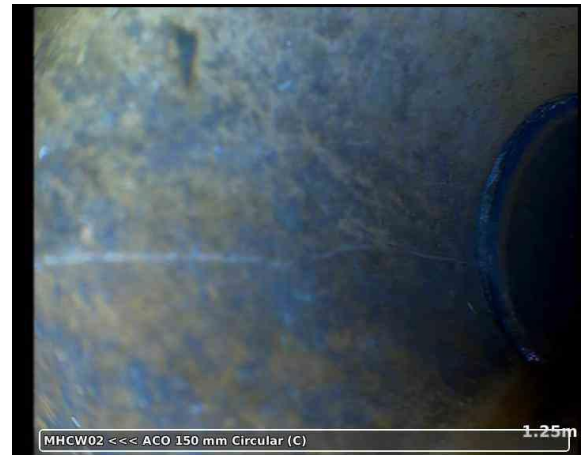
20260203-133243-snap0005.jpg, 00:01:21, 1.25 m  
Pipe size changes, new size(s), 100mm high

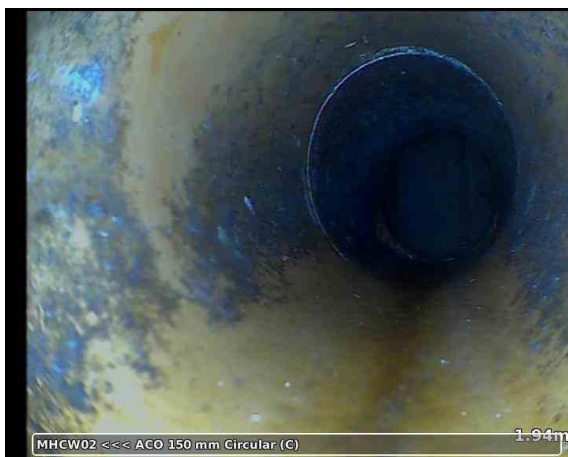
20260203-133243-snap0006.jpg, 00:01:40, 1.94 m  
Line deviates right

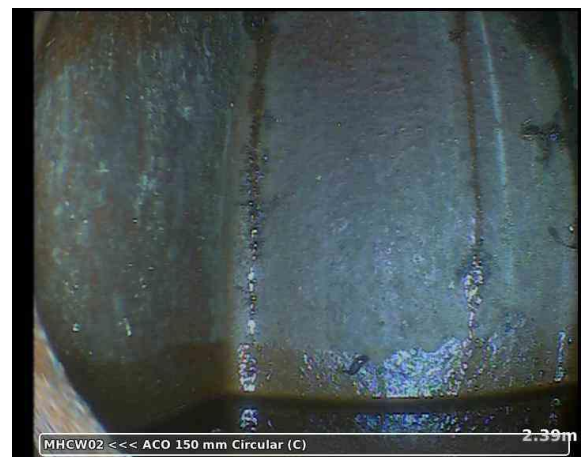
20260203-133243-snap0007.jpg, 00:01:58, 2.39 m  
General remark, ACO
