## Leak detection text

## Case study 1

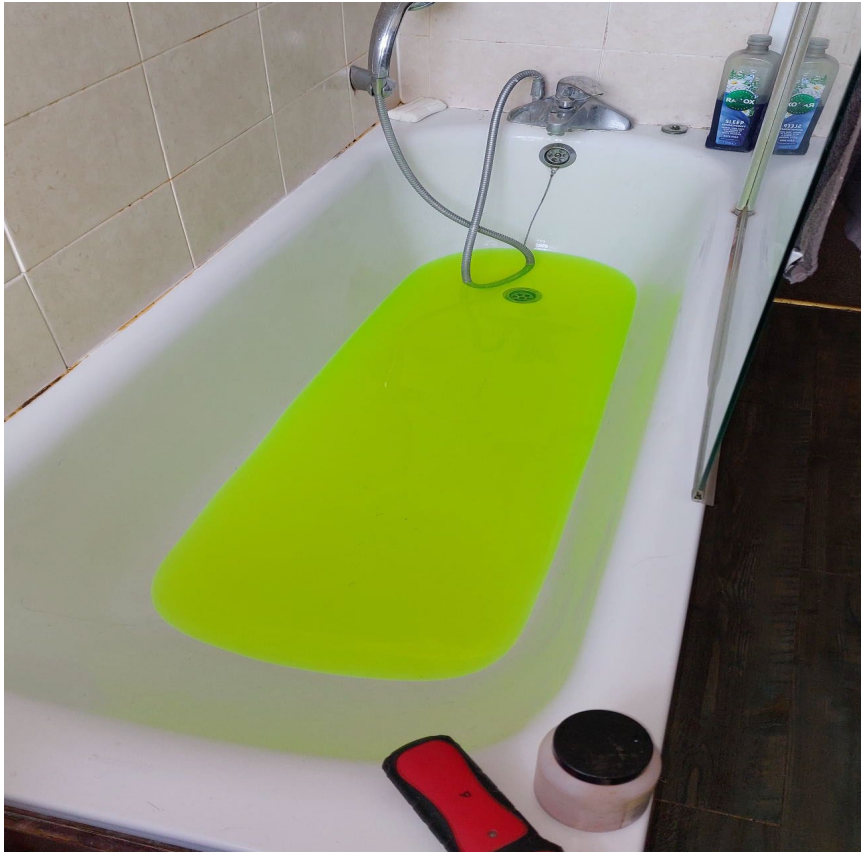
Used coloured tracing dye

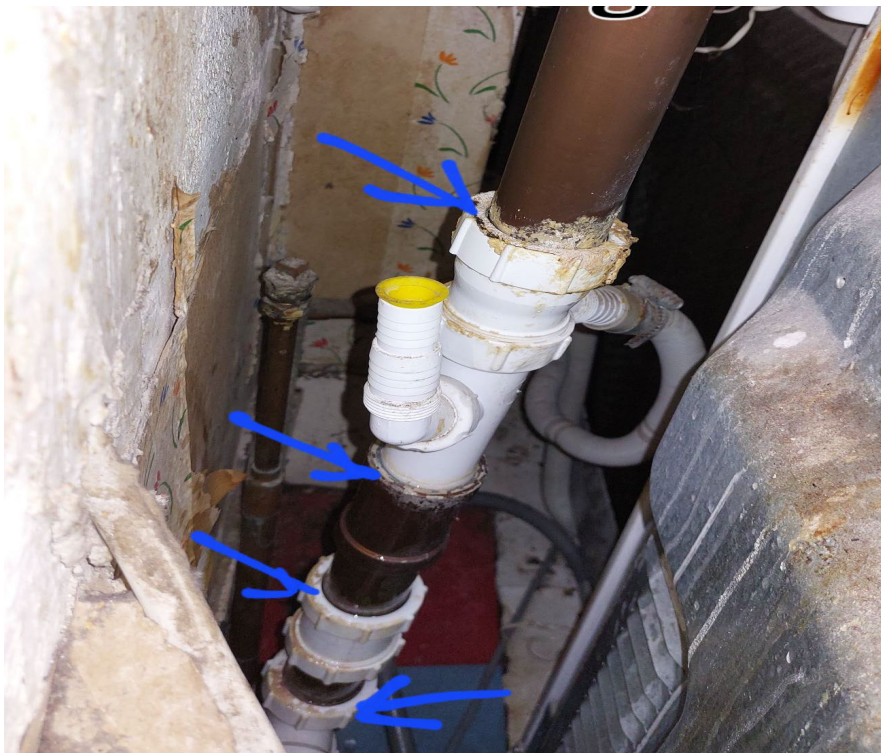
- Ground floor flat experiencing leaks from above into their kitchen.
- Completed leak detection inspections using thermal imaging equipment and tracing dye within the kitchen of the flat above.
- Observed numerous leaks exist due to missing seals/gaskets/washers and defective pipe work fitted.
- Replaced the defective section of waste pipe and fitted new seals/gaskets/washers and couplings.
- Tested the pipework with water. No leaks observed within the ground floor flat once repairs completed.

Found the leaking pipe work

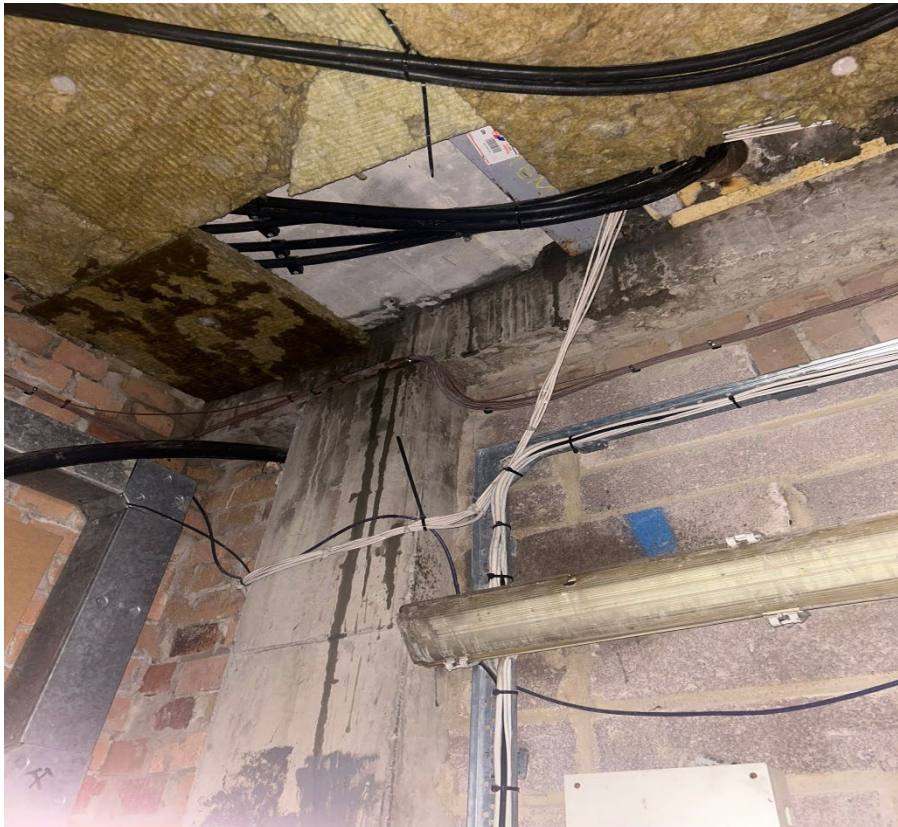
Leaks entering an electrical cupboard from the bathroom of the flat above

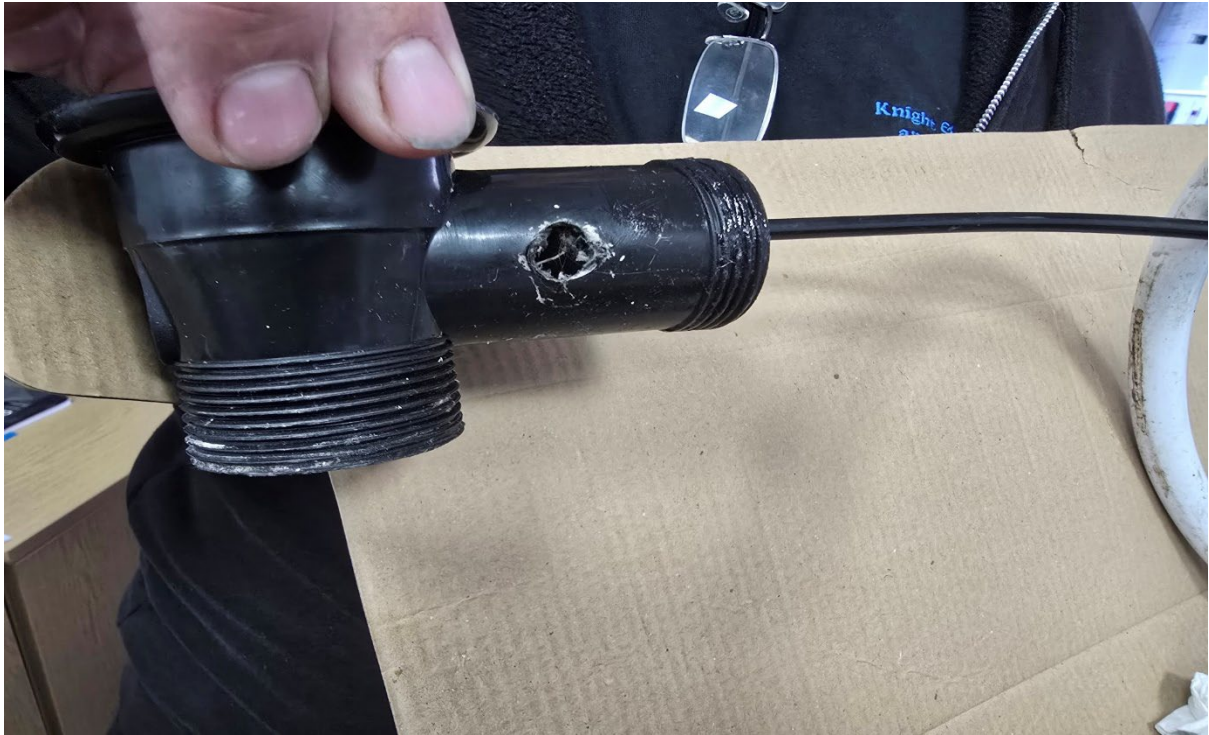
- Ground floor electrical cupboard has a leak from the bathroom of a flat above.
- Completed leak detection inspections using thermal imaging equipment and tracing dye within the bathroom of the flat above.
- Observed the bath plug waste contains a hole so every time the bath is used, leaks arise.
- Removed and replaced the bath plug waste.
- Tested the bath and confirmed no further leaks detected.

Removed old plug waste and confirmed a hole exists causing the leaks

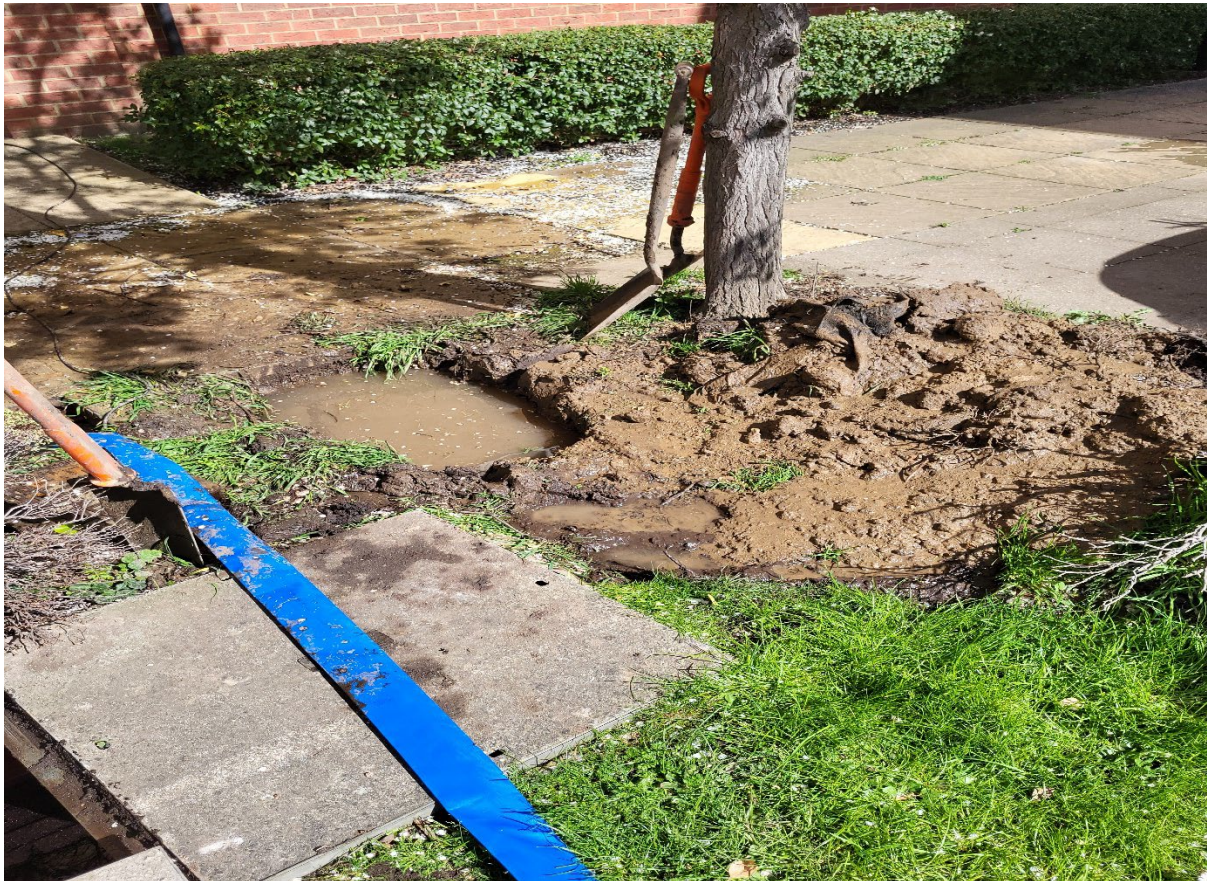
Attended site for flooded path/gardens

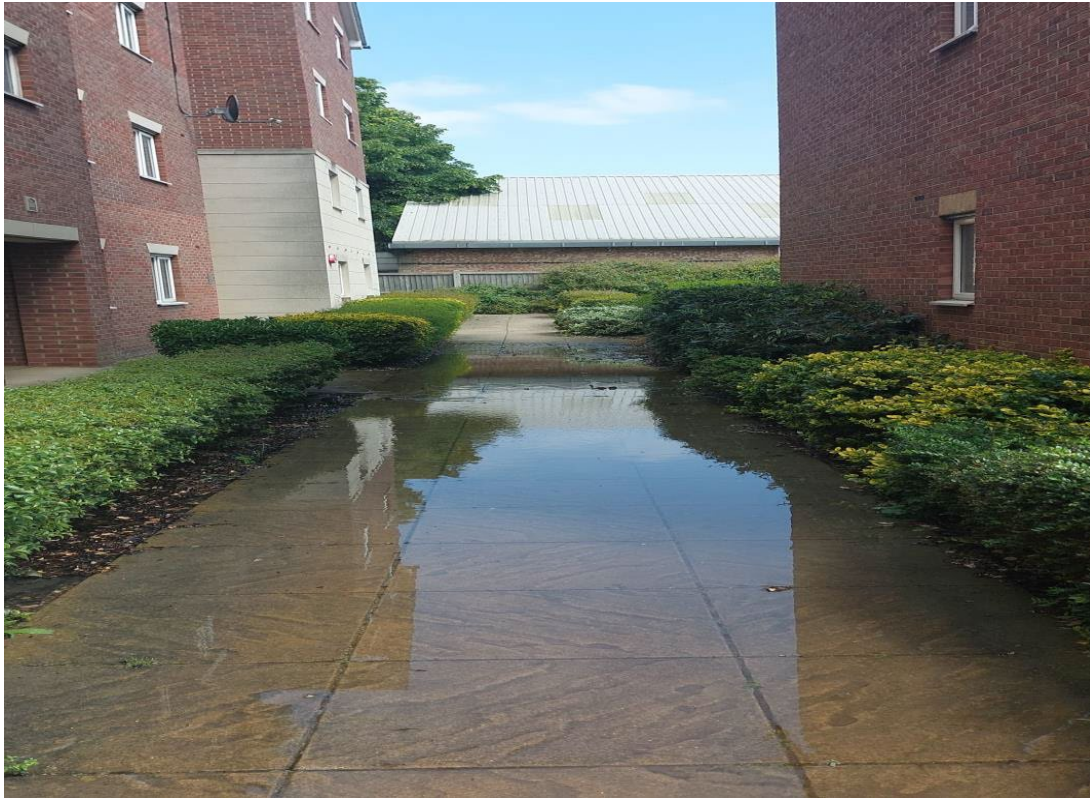
Attended site for flooded path/gardens

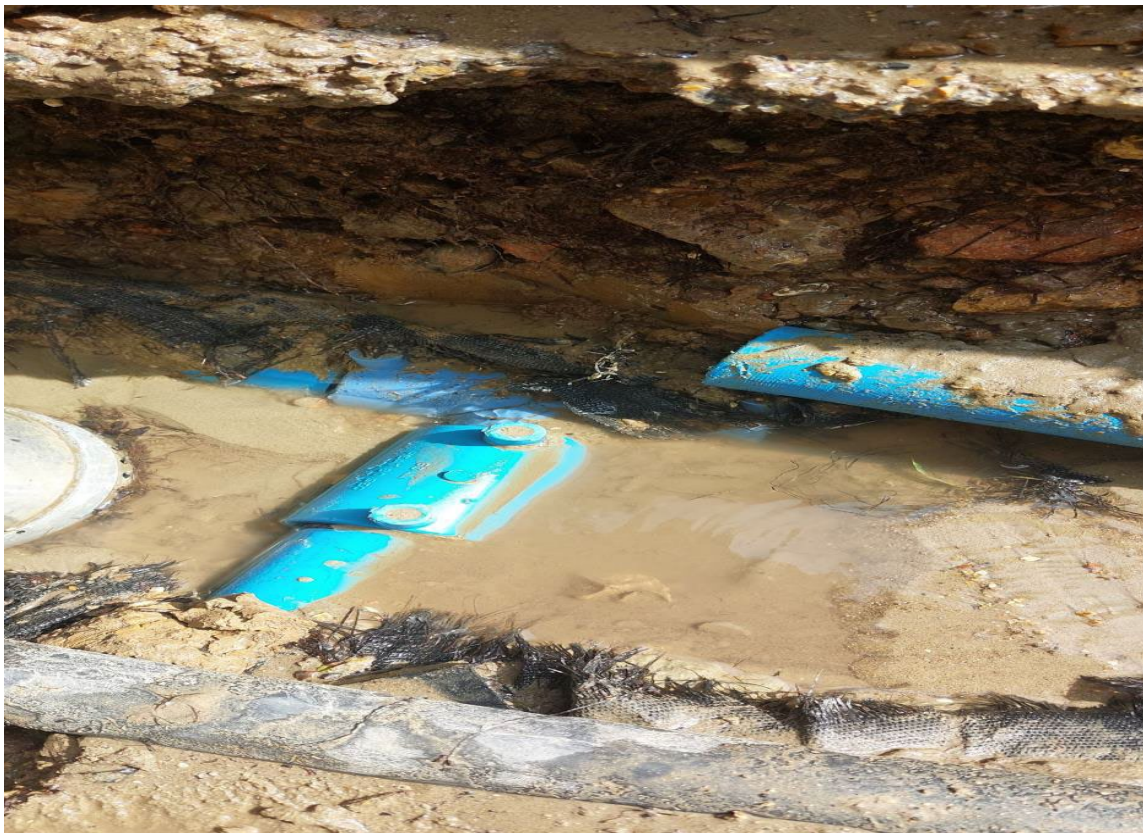
Excavated and found the damaged cold water supply pipe

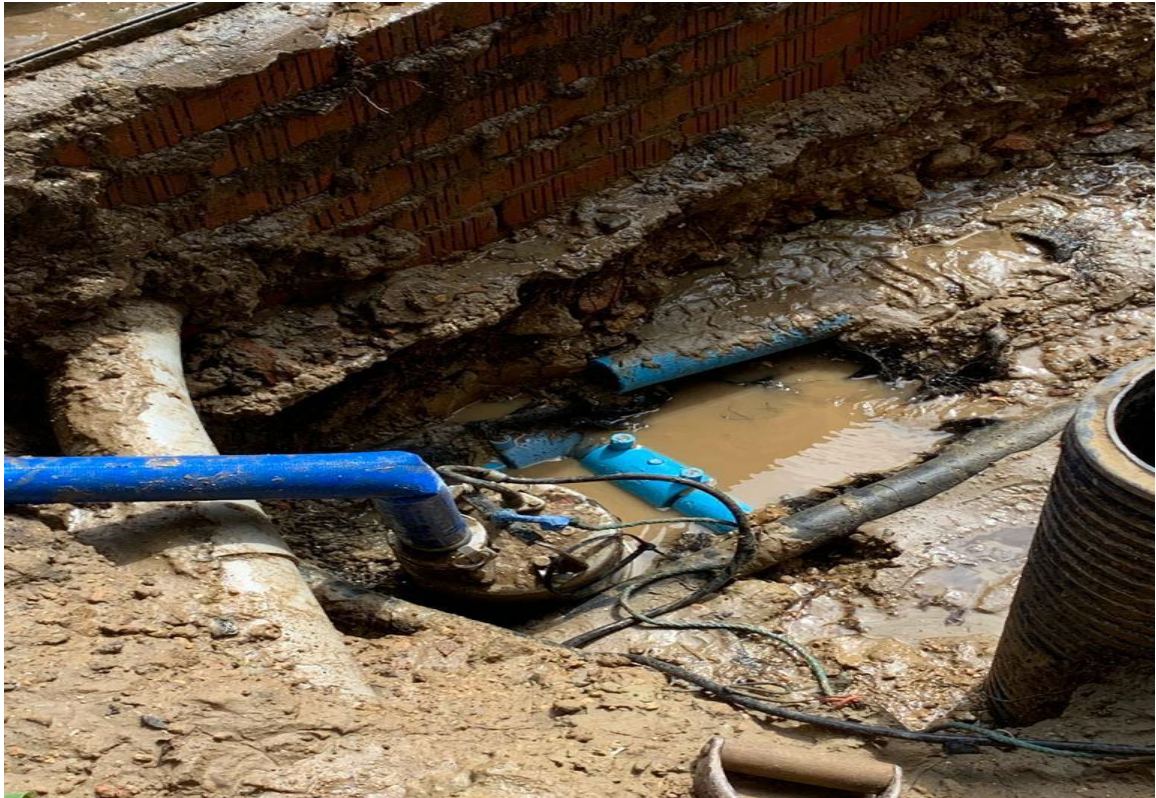
Defective and damaged main water supply pipe exposed
